SR 26 over Salamonie River, Bridge No. 026-38-03430A (NBI 7040) Project

HISTORIC PROPERTY REPORT

**Portland, Wayne Township, Jay County, Indiana
Des. No. 1600828**

WATERS OF THE U.S. DETERMINATION REPORT
S.R. 26 over Salamonie River
Bridge Replacement
Wayne Township, Jay County, Indiana
Des. No. 1600828
Prepared By: Cory Shumate, Metric Environmental, LLC
April 2, 2020

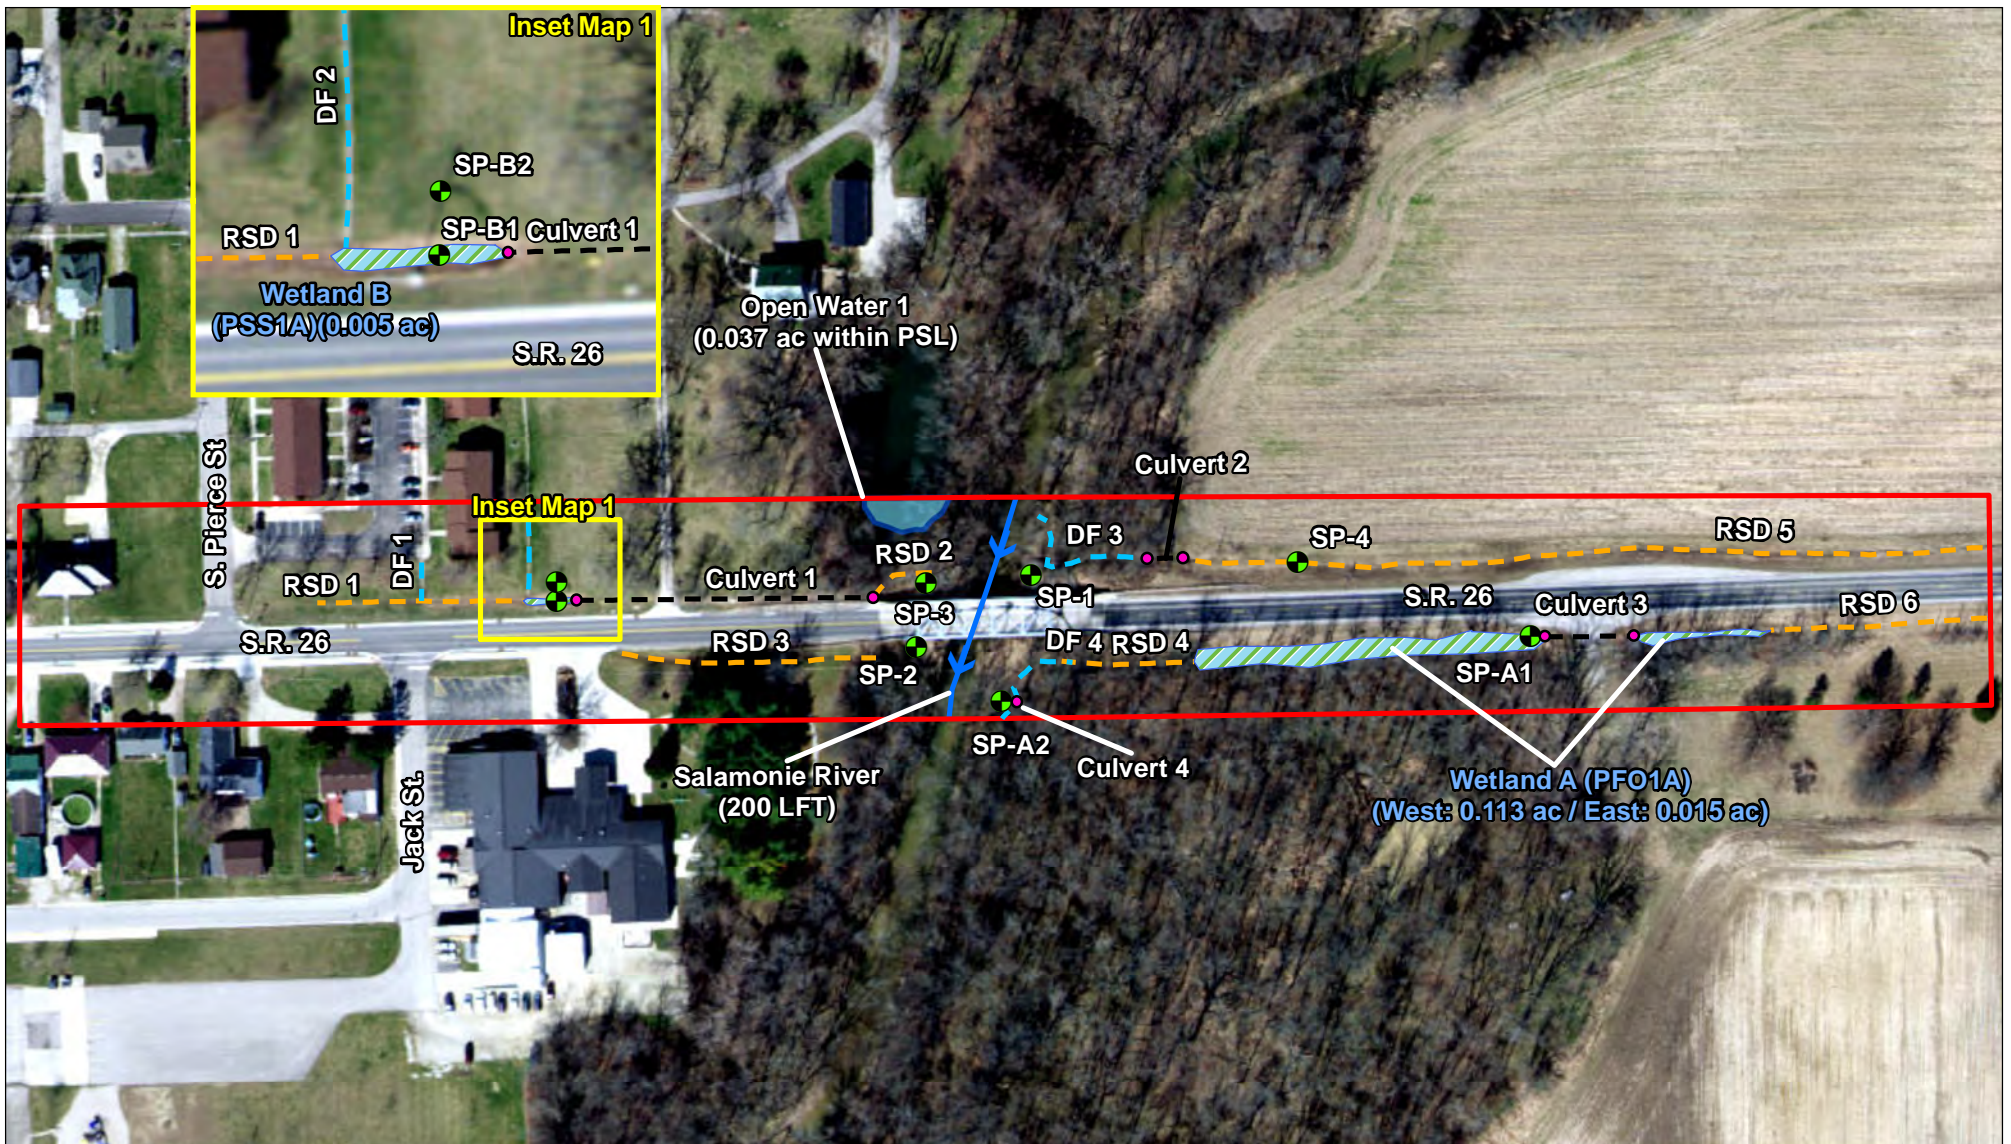
Exhibit 4 - Waters Delineation Map
 S.R. 26 over Salamonie River
 Bridge Replacement
 Wayne Township, Jay County, IN
 Des. No. 1600828
 Metric Project No. 17-0082
 Map Date: 9/3/2019
 Map Author: Cory Shumate

Two wetlands were observed within the PSL. Descriptions of the wetlands and corresponding sampling points are provided below.

One stream, Salamonie River, was observed within the PSL during the field reconnaissance. A description of the stream is provided below.

One open water feature was observed within the PLS during the field reconnaissance and is noted on **Exhibit 5**. Open Water 1 was located in the northcentral portion of the PSL and 0.037 ac. was contained within the PSL.

Six roadside ditches (RSD) and four drainage features (DF) were identified within the PSL. These features aided in stormwater and/or roadside drainage. No OHWM was observed in these features, so they are likely non-jurisdictional.

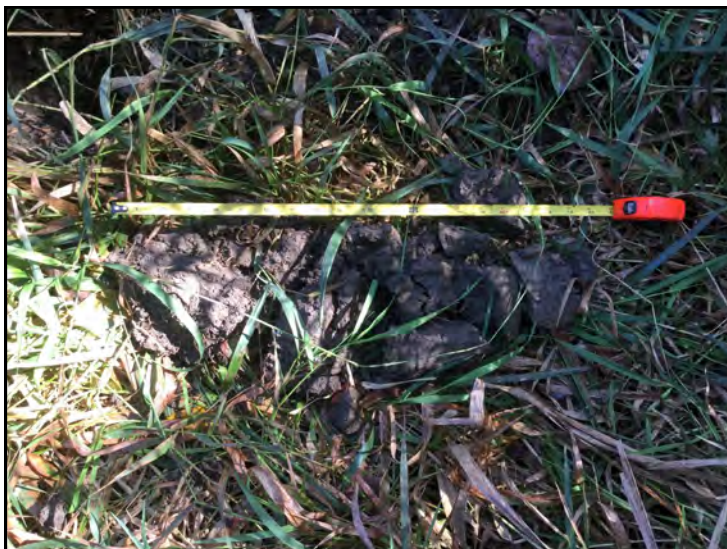
1. View of SP-A1, Wetland A, soil profile.

Profile Description: (Describe to the depth needed to document the indicator or confirm the absence of indicators.)								
Depth (inches)	Matrix		Redox Features				Texture	Remarks
	Color (moist)	%	Color (moist)	%	Type ¹	Loc ²		
0-11	10YR 3/1	85	5YR 3/4	15	C	PL	SiCL	Prominent redox concentrations.
11-20	10YR 3/1	80	10YR 5/8	15	C	M	SiCL	Prominent redox concentrations.
			5YR 3/4	5	C	PL		Prominent redox concentrations.

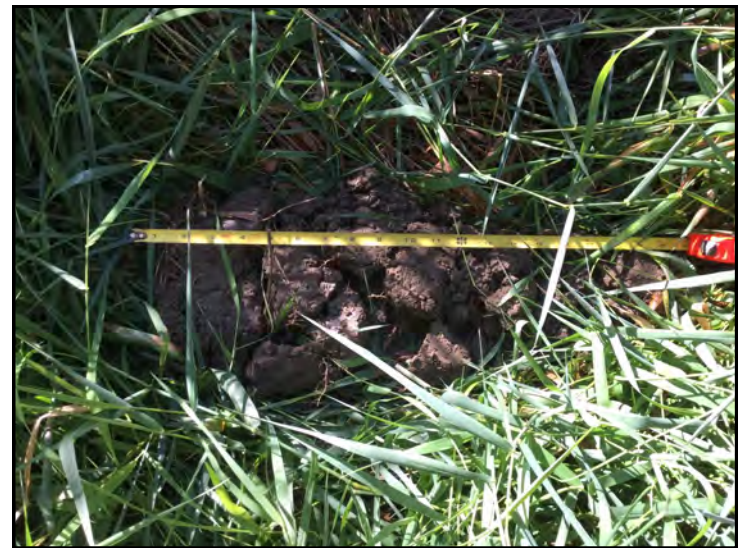
16. View of SP-2, upland sampling point 2, soil profile.

SP-2 was located on a stream terrace south of S.R. 26 and west of Salamonie River. The dominant vegetation at this sampling point was reed canary grass (*Phalaris arundinacea*, FACW) and great ragweed (*Ambrosia trifida*, FAC) in the herb stratum. This met the hydrophytic vegetation indicators of dominance test (100 percent) and prevalence index (2.20). To a depth of 20 in., the soil in the test pit was a silty clay loam. From 0 to 20 in., the soil exhibited a matrix color of 10YR 4/2 (100 percent). This did not meet any of the hydric soil indicators. Indicators of wetland hydrology observed included geomorphic position (D2) due to the sampling point's location on a stream terrace, and FAC-neutral test (D5). Since only two of the three required wetland criteria were met, this area did not qualify as a wetland.

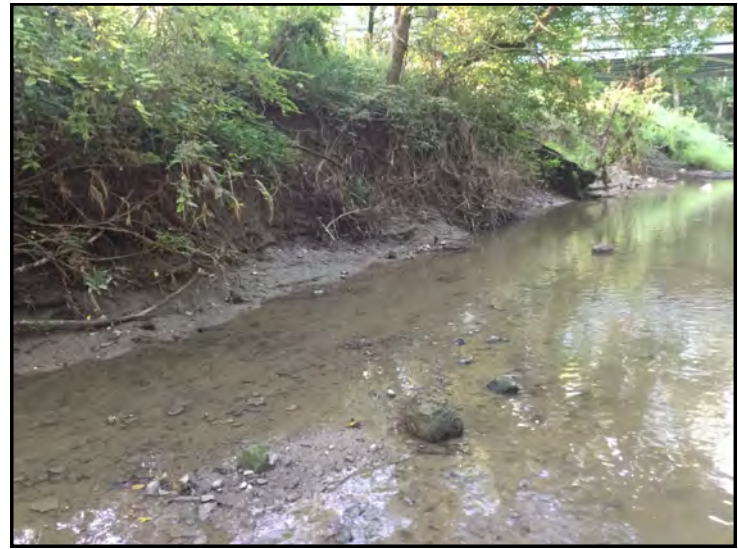
26. View of eastern bank of Salamonie River and structure to be replaced (Bridge No. 026-38-03430 A/NIBI No. 007040) from northern PSL, looking southeast.

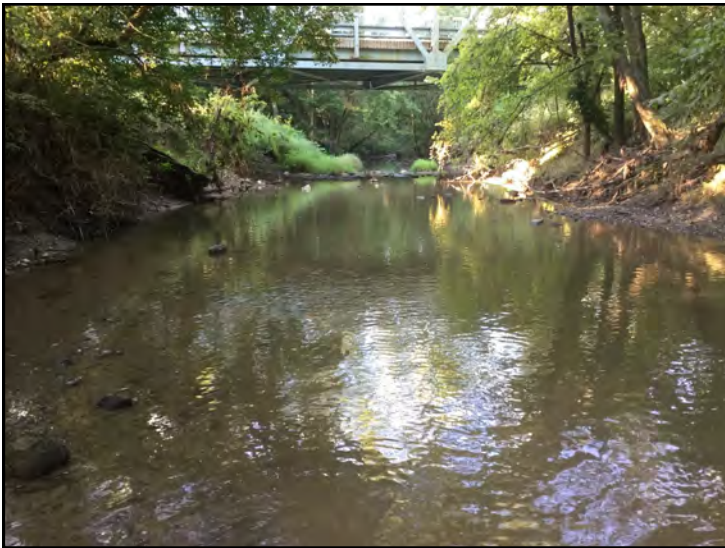
27. View of Salamonie River and structure to be replaced (Bridge No. 026-38-03430 A/NIBI No. 007040) from northern PSL, looking southwest (downstream).

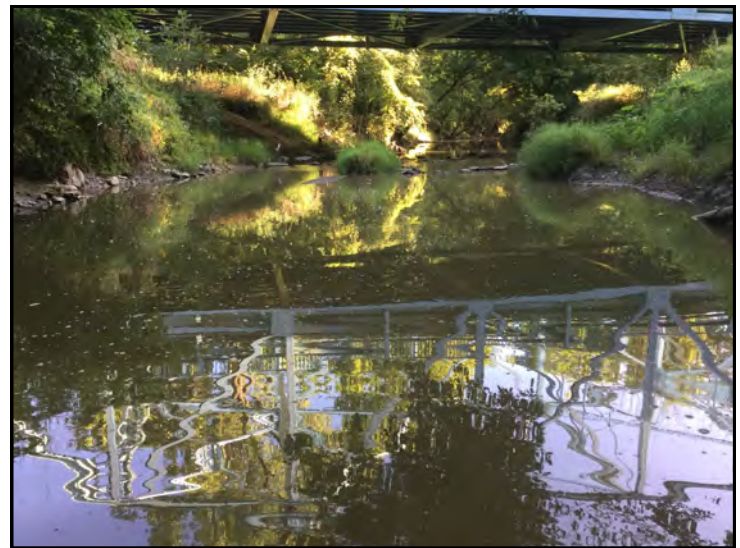
36. View of Salamonie River and structure to be replaced (Bridge No. 026-38-03430 A/NIBI No. 007040) from southern PSL, looking northeast (upstream).

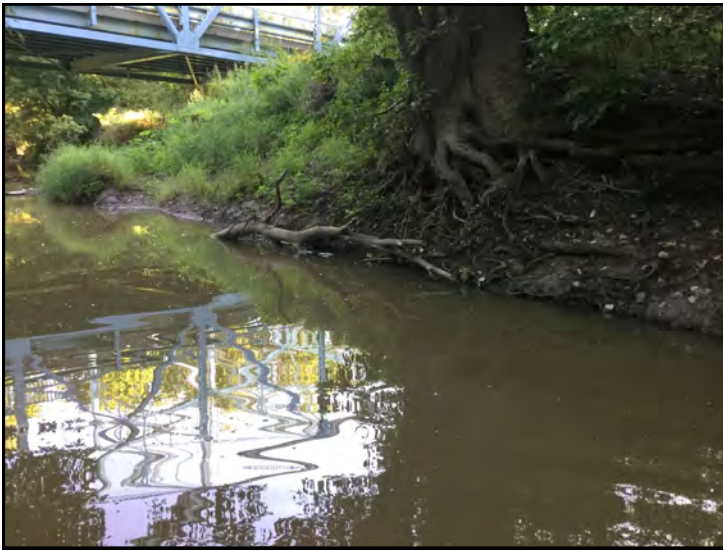
37. View of eastern bank of Salamonie River and structure to be replaced (Bridge No. 026-38-03430 A/NIBI No. 007040) from southern PSL, looking northeast.

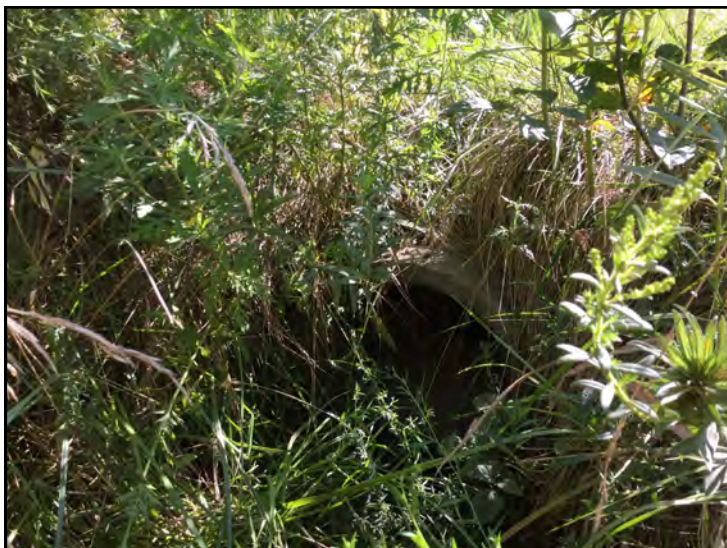
47. From inlet (western end) of Culvert 1, view of Culvert 1, looking east.

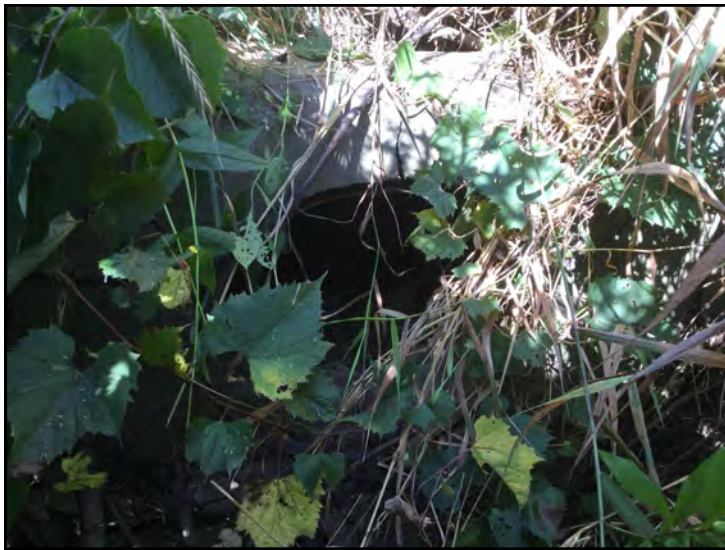
57. View of Culvert 2 inlet, looking west.

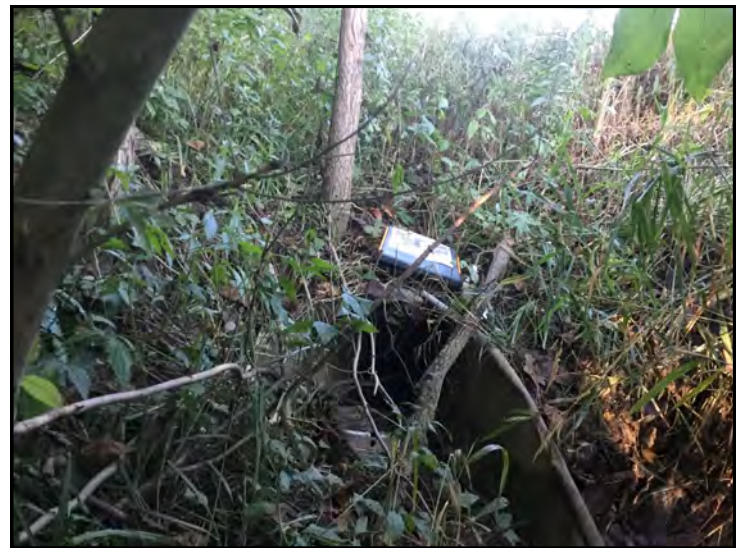
64. View of Culvert 3 inlet, looking west.

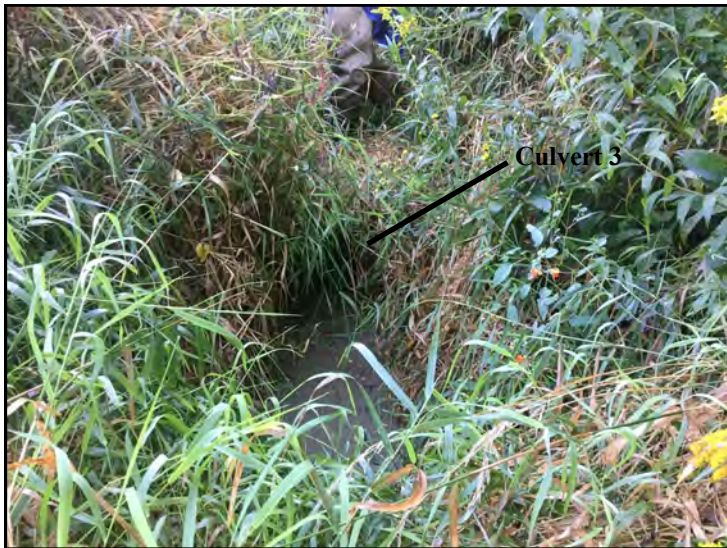
65. View of Culvert 3 outlet, looking east.

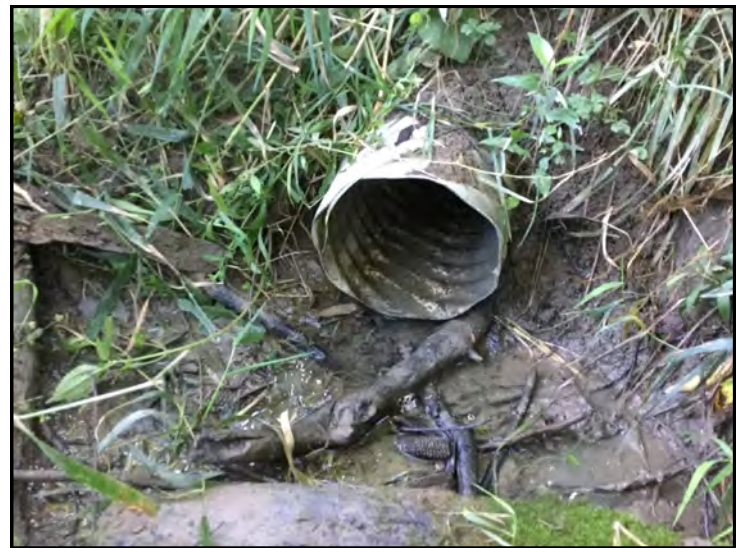
72. View of Culvert 4, looking northeast.
